Moisture and Housing Research at USDA - FPL

Charles Carll
Anton TenWolde

This presentation concerns

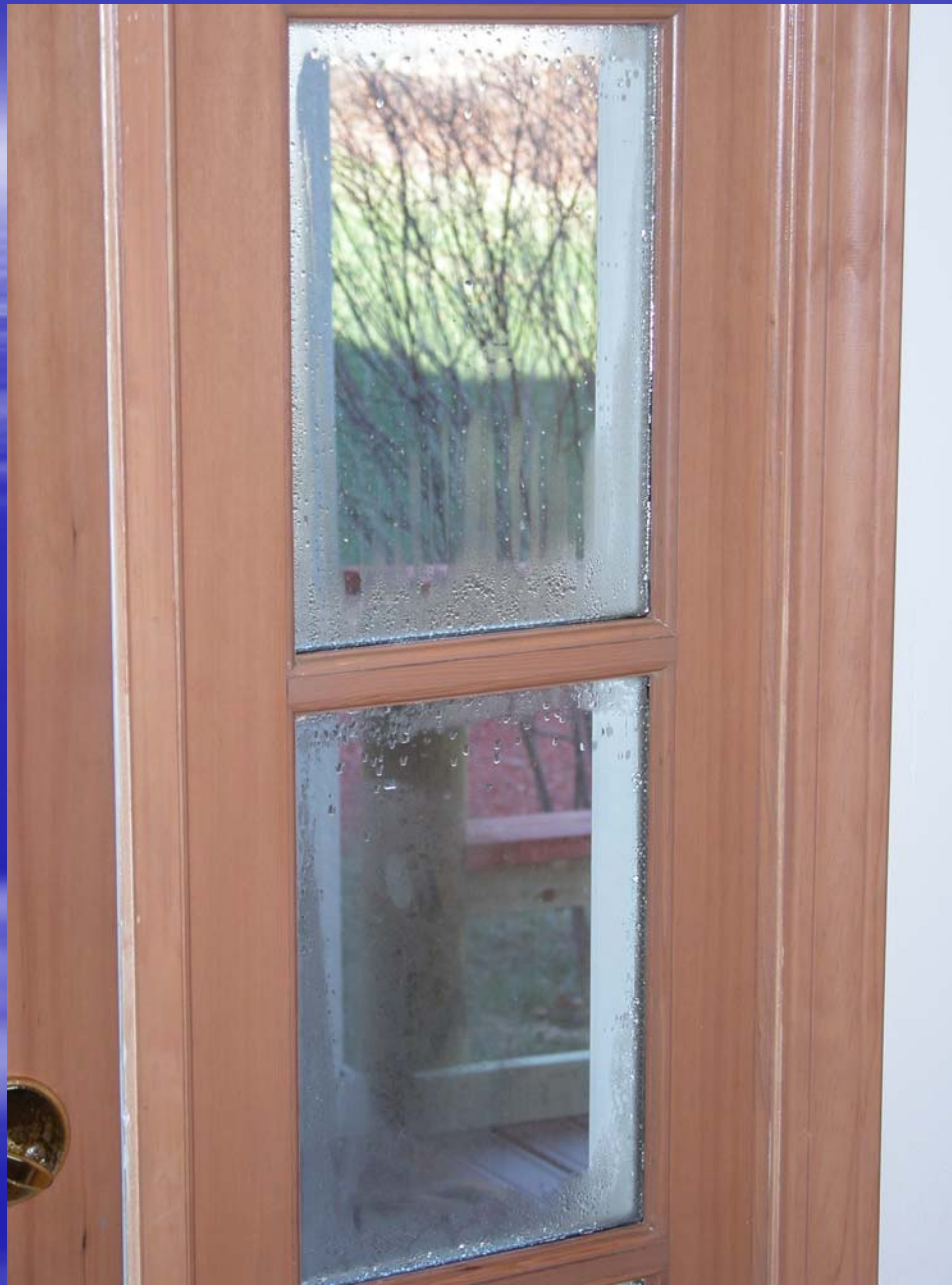
Heavy condensation
on mediocre IGU's
when outdoor temp
fell below 10° F

But condensation
only on glass - - -
No water on, or
staining of, sash

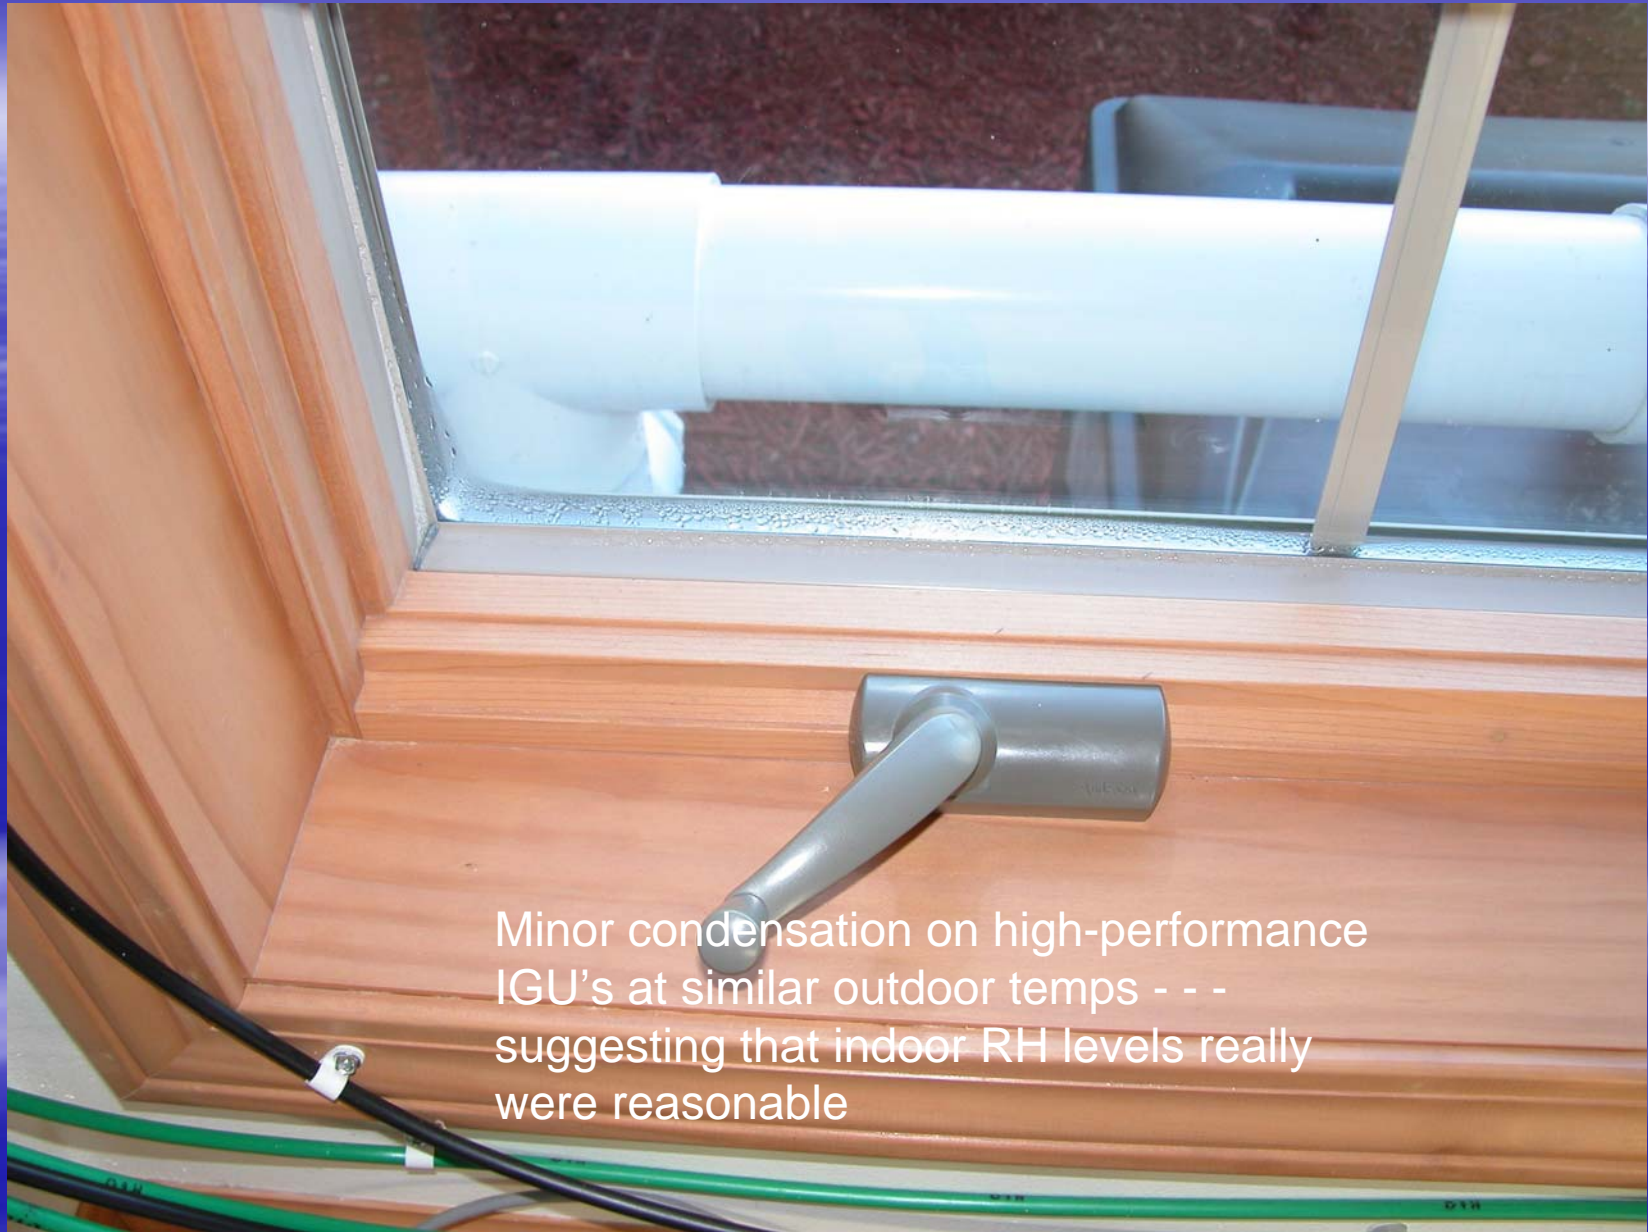
Minor condensation on high-performance IGU's at similar outdoor temps - - - suggesting that indoor RH levels really were reasonable

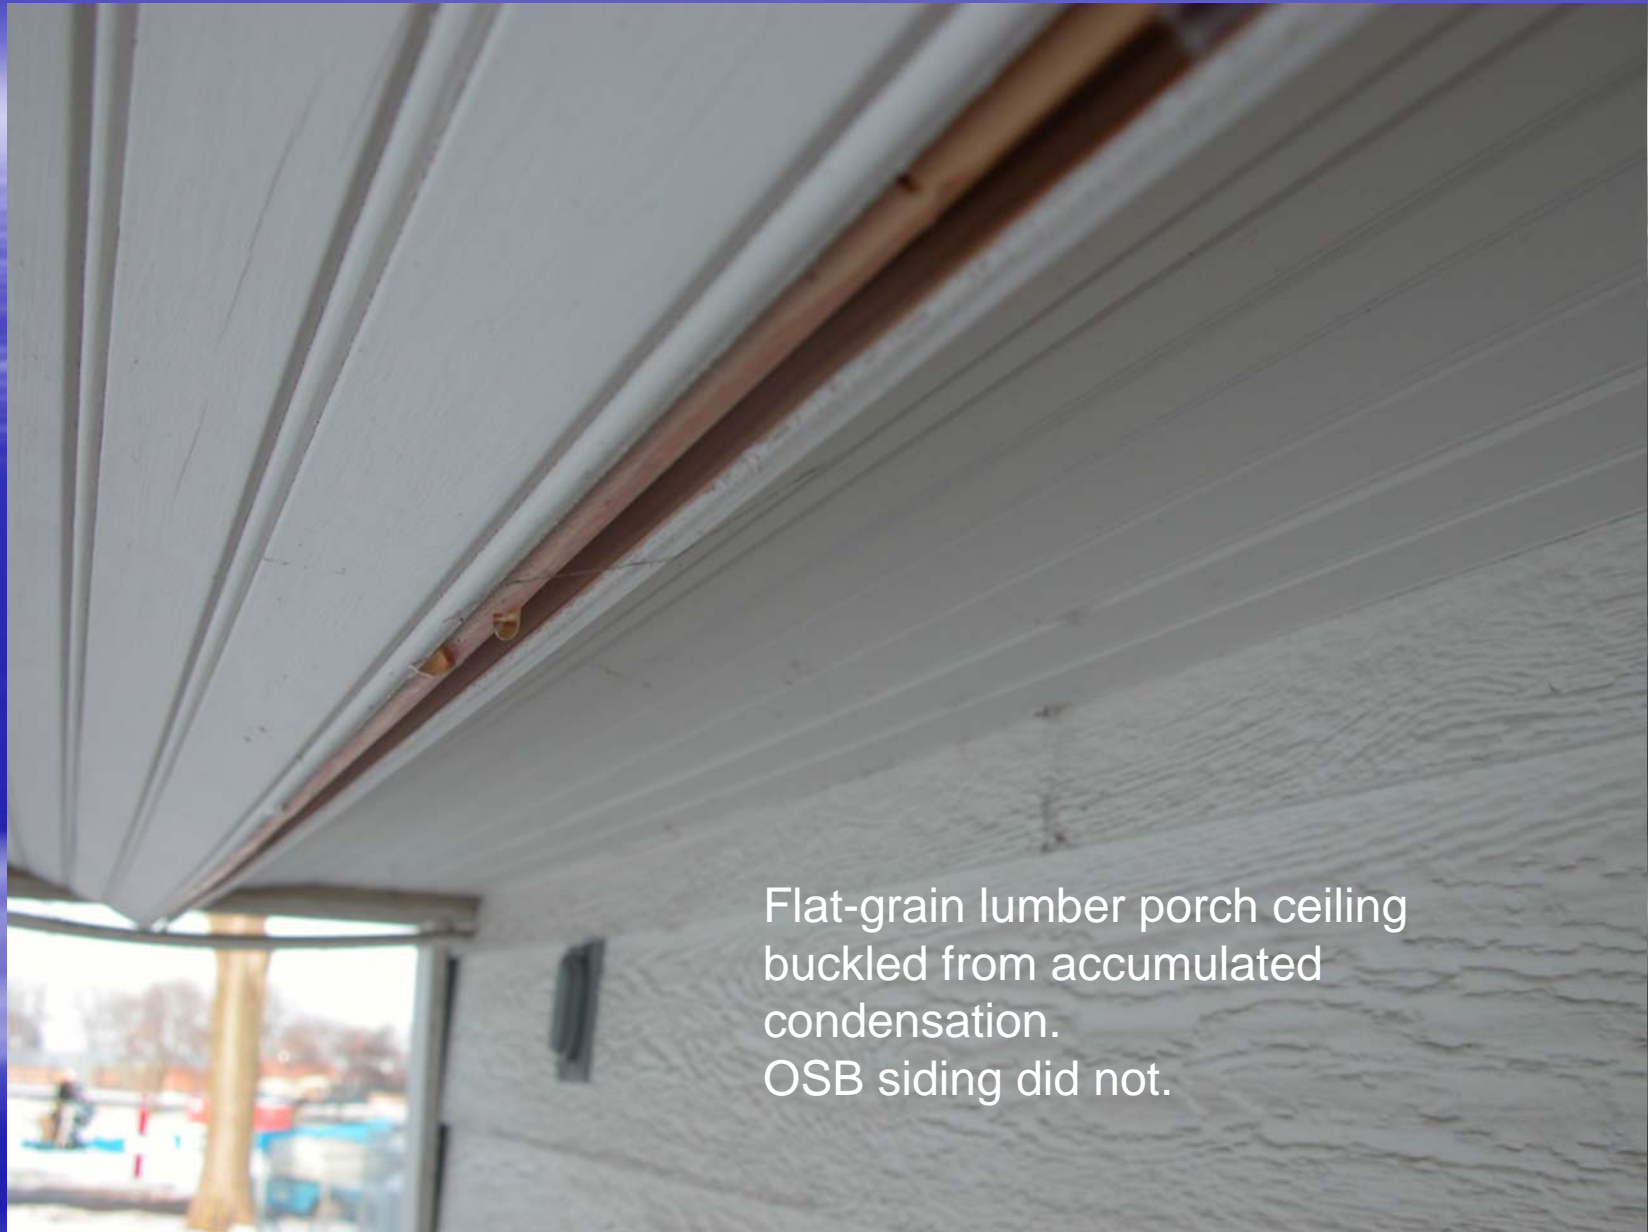
Flat-grain lumber porch ceiling
buckled from accumulated
condensation.
OSB siding did not.

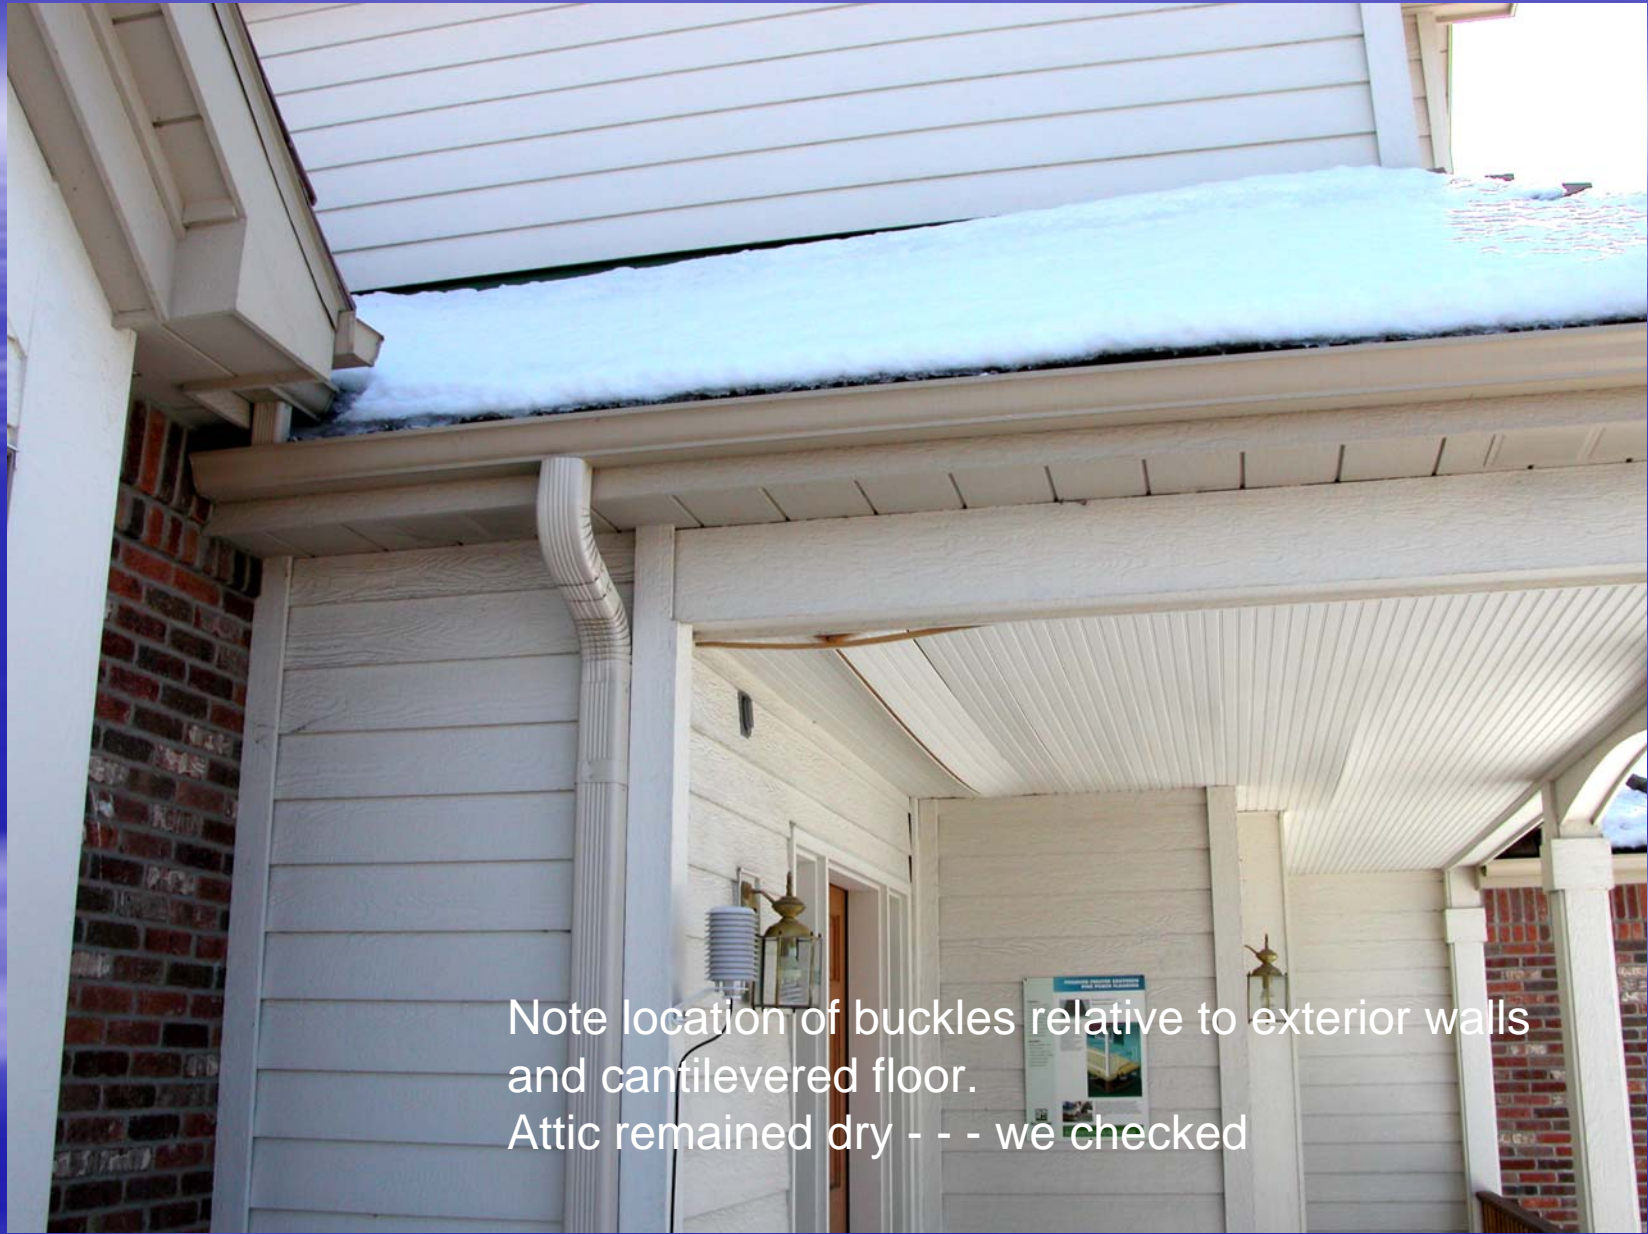
Note location of buckles relative to exterior walls and cantilevered floor.
Attic remained dry - - - we checked

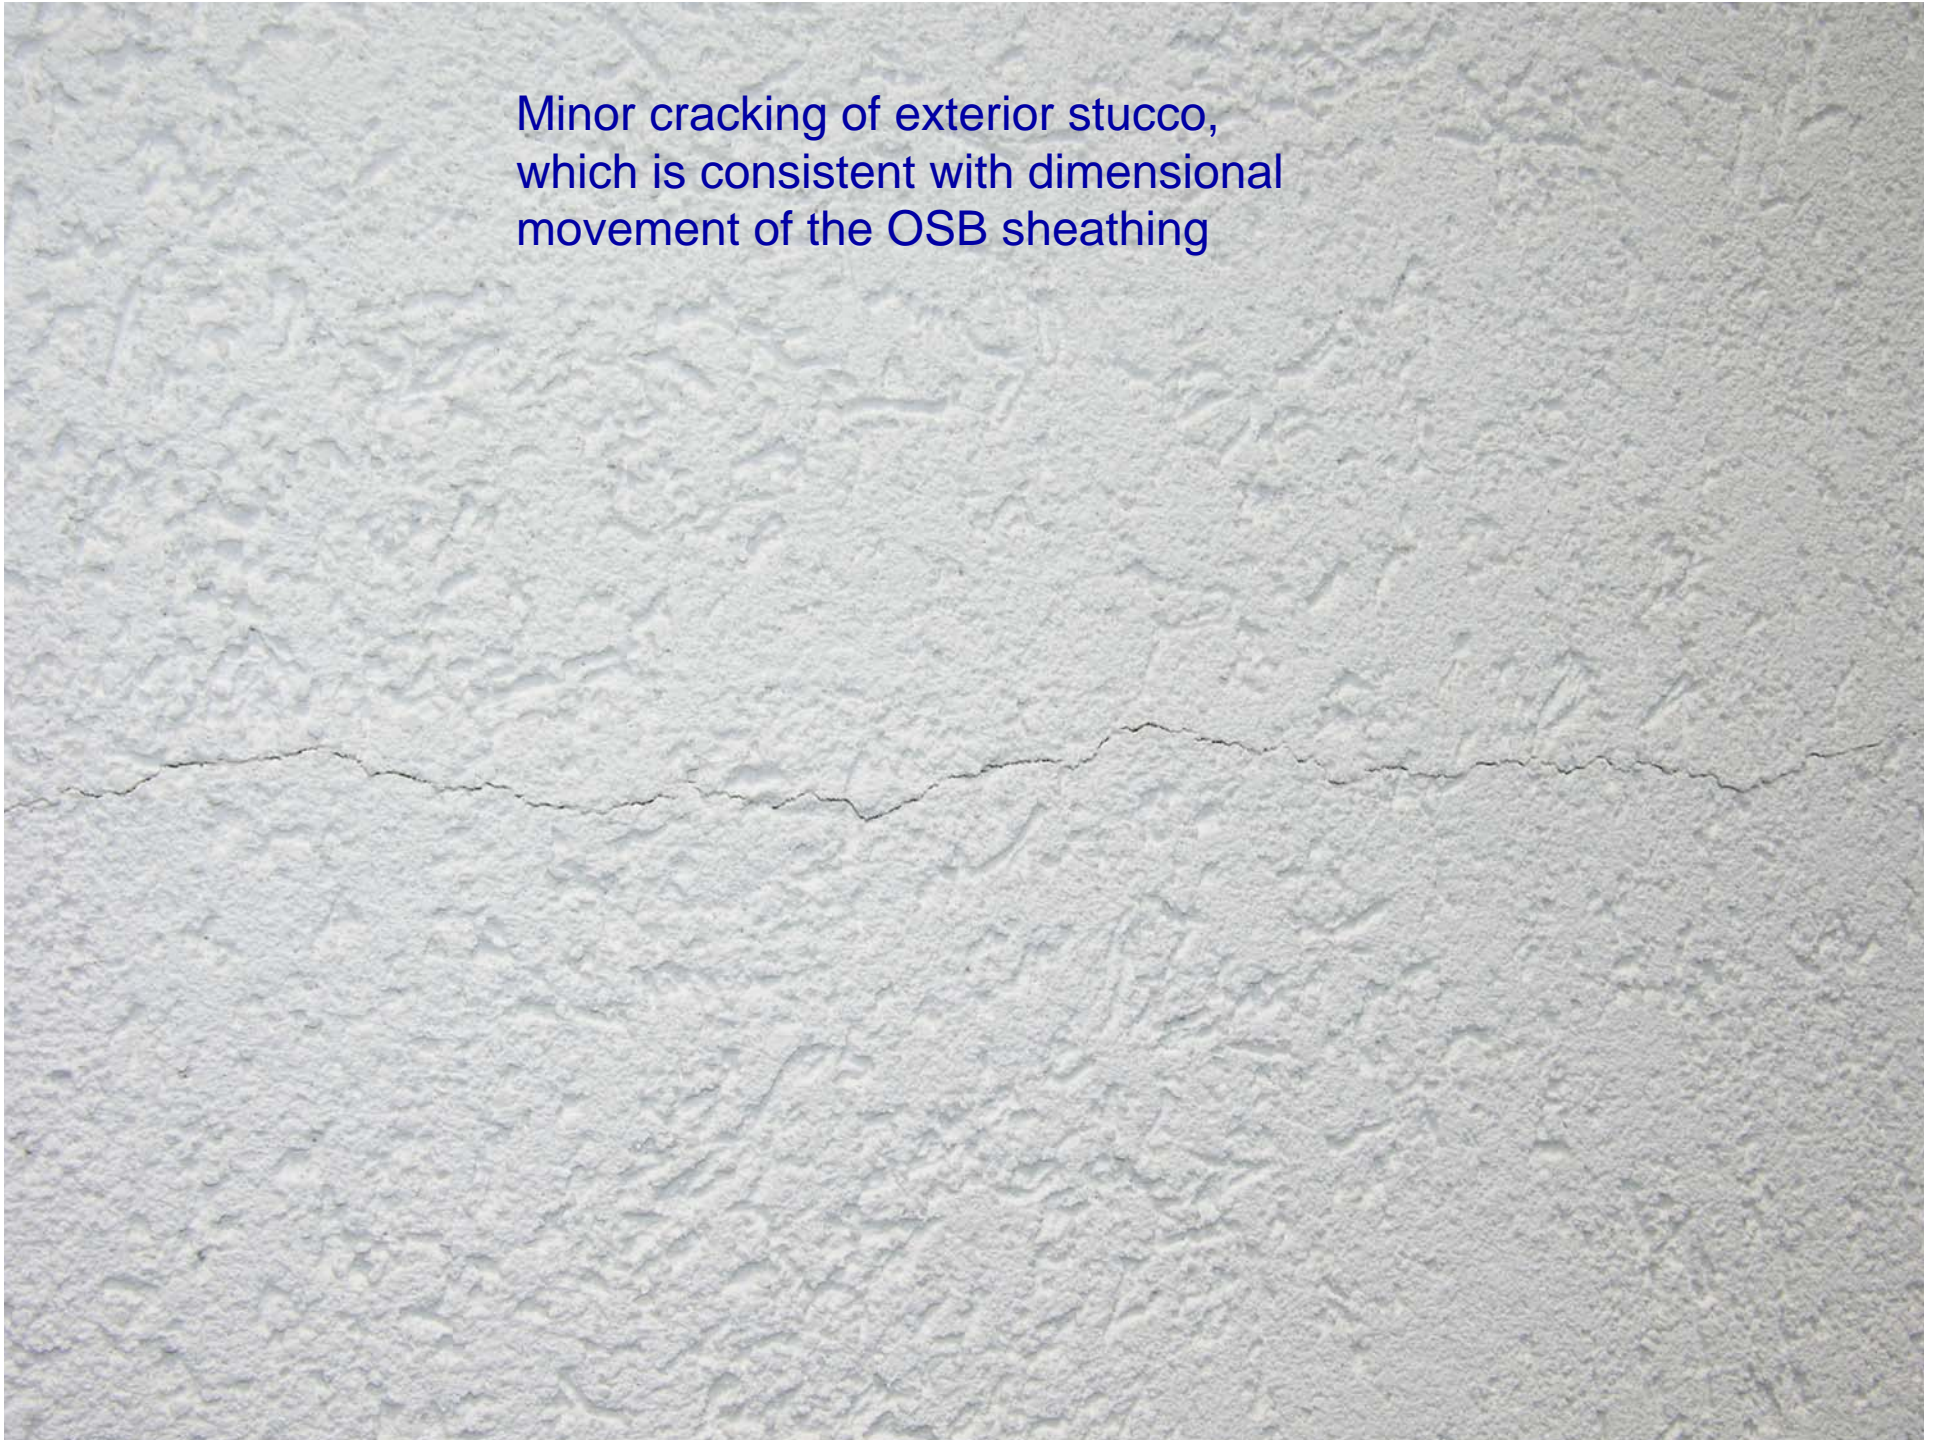
Minor cracking of exterior stucco,
which is consistent with dimensional
movement of the OSB sheathing

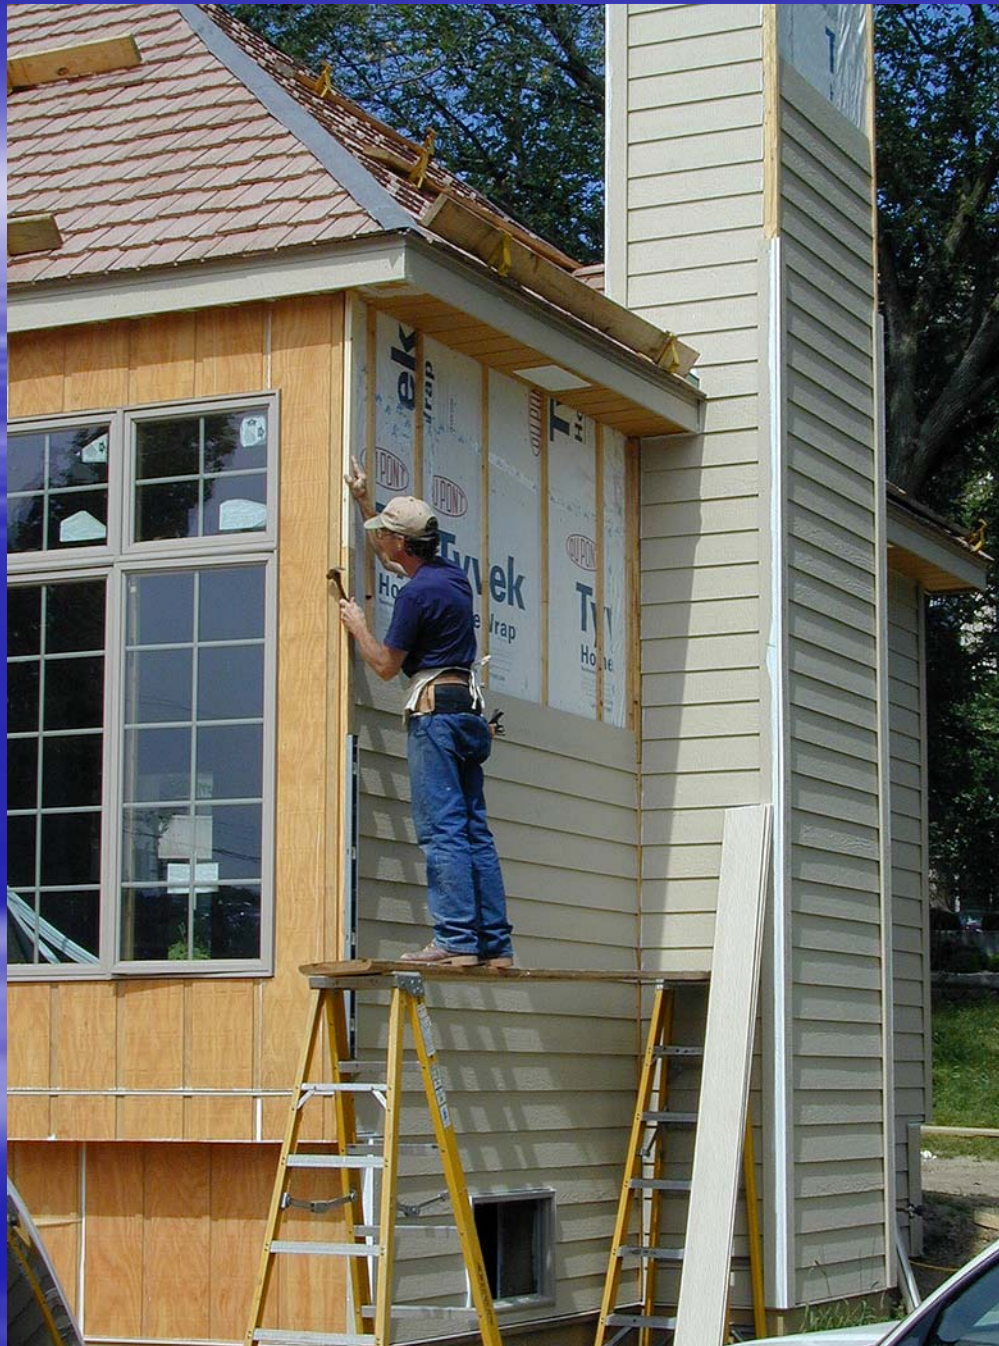
Shows that the spaced siding was only spaced - - not ventilated. Soffit facing was on before furring strips went up.

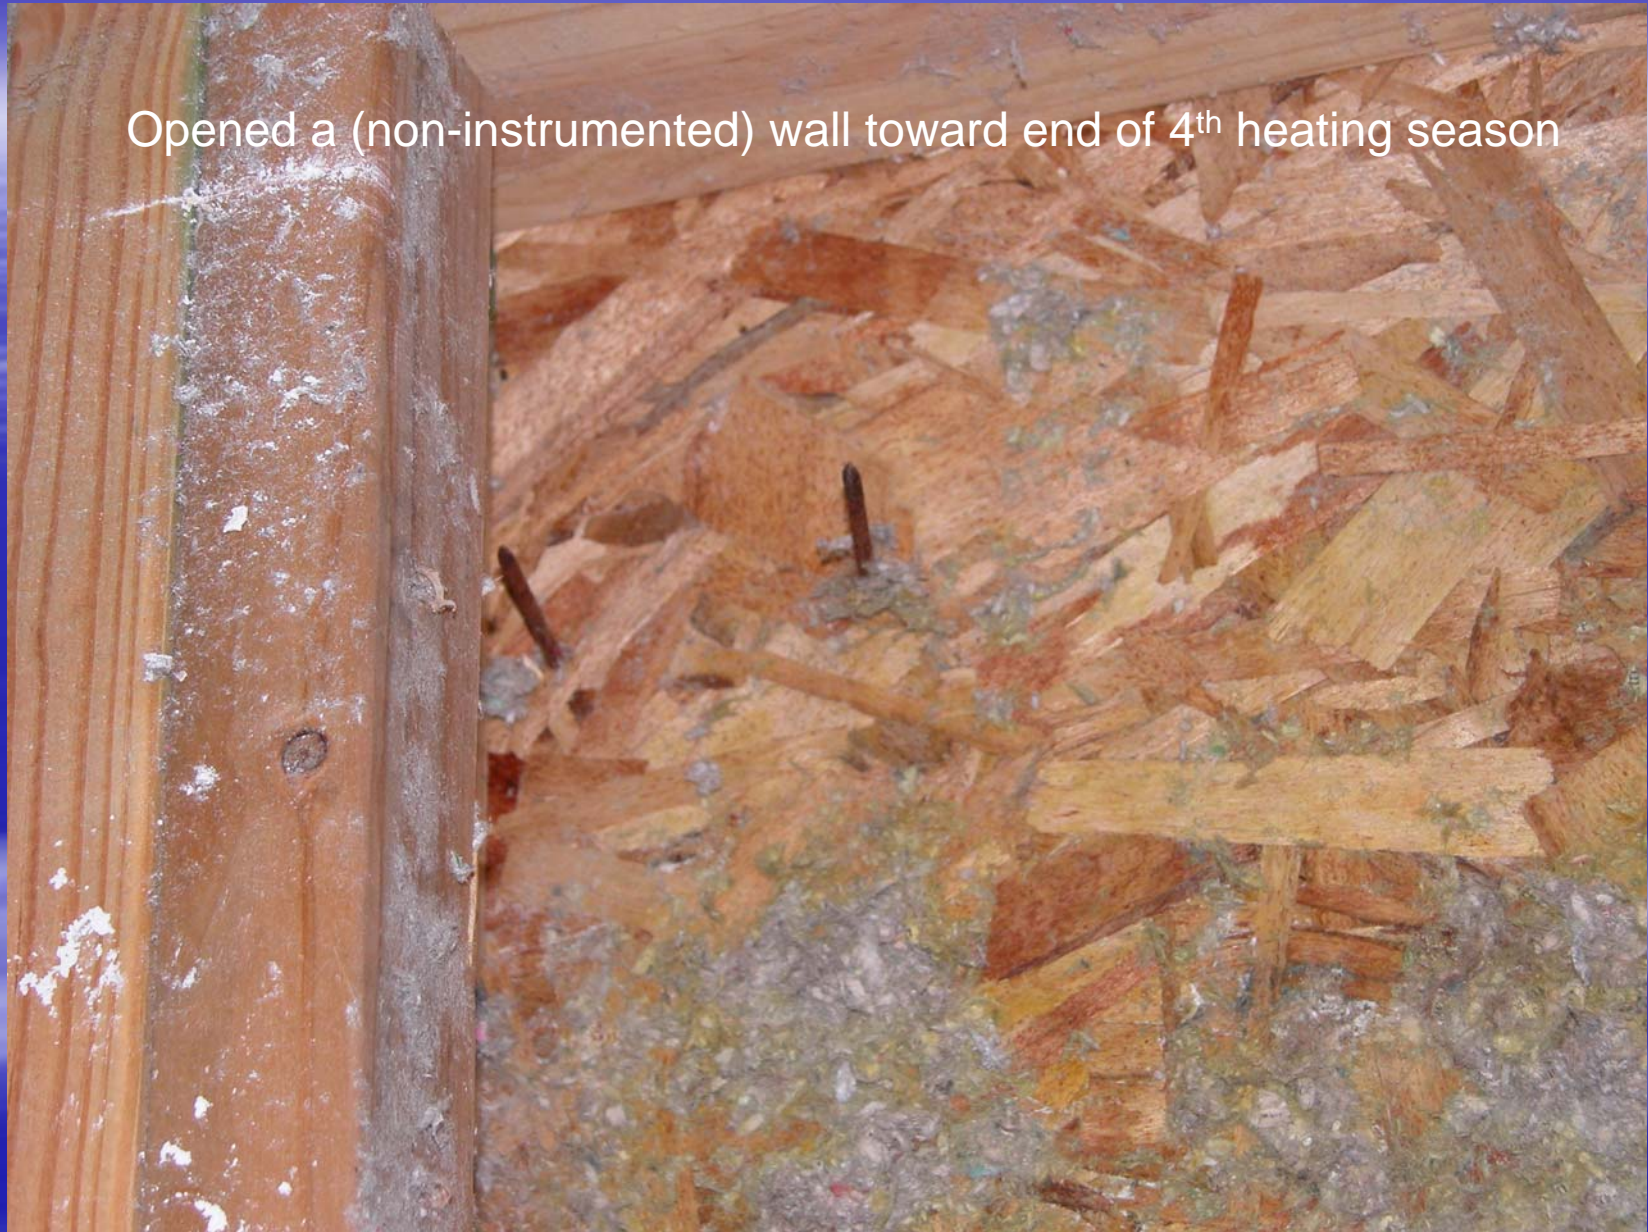
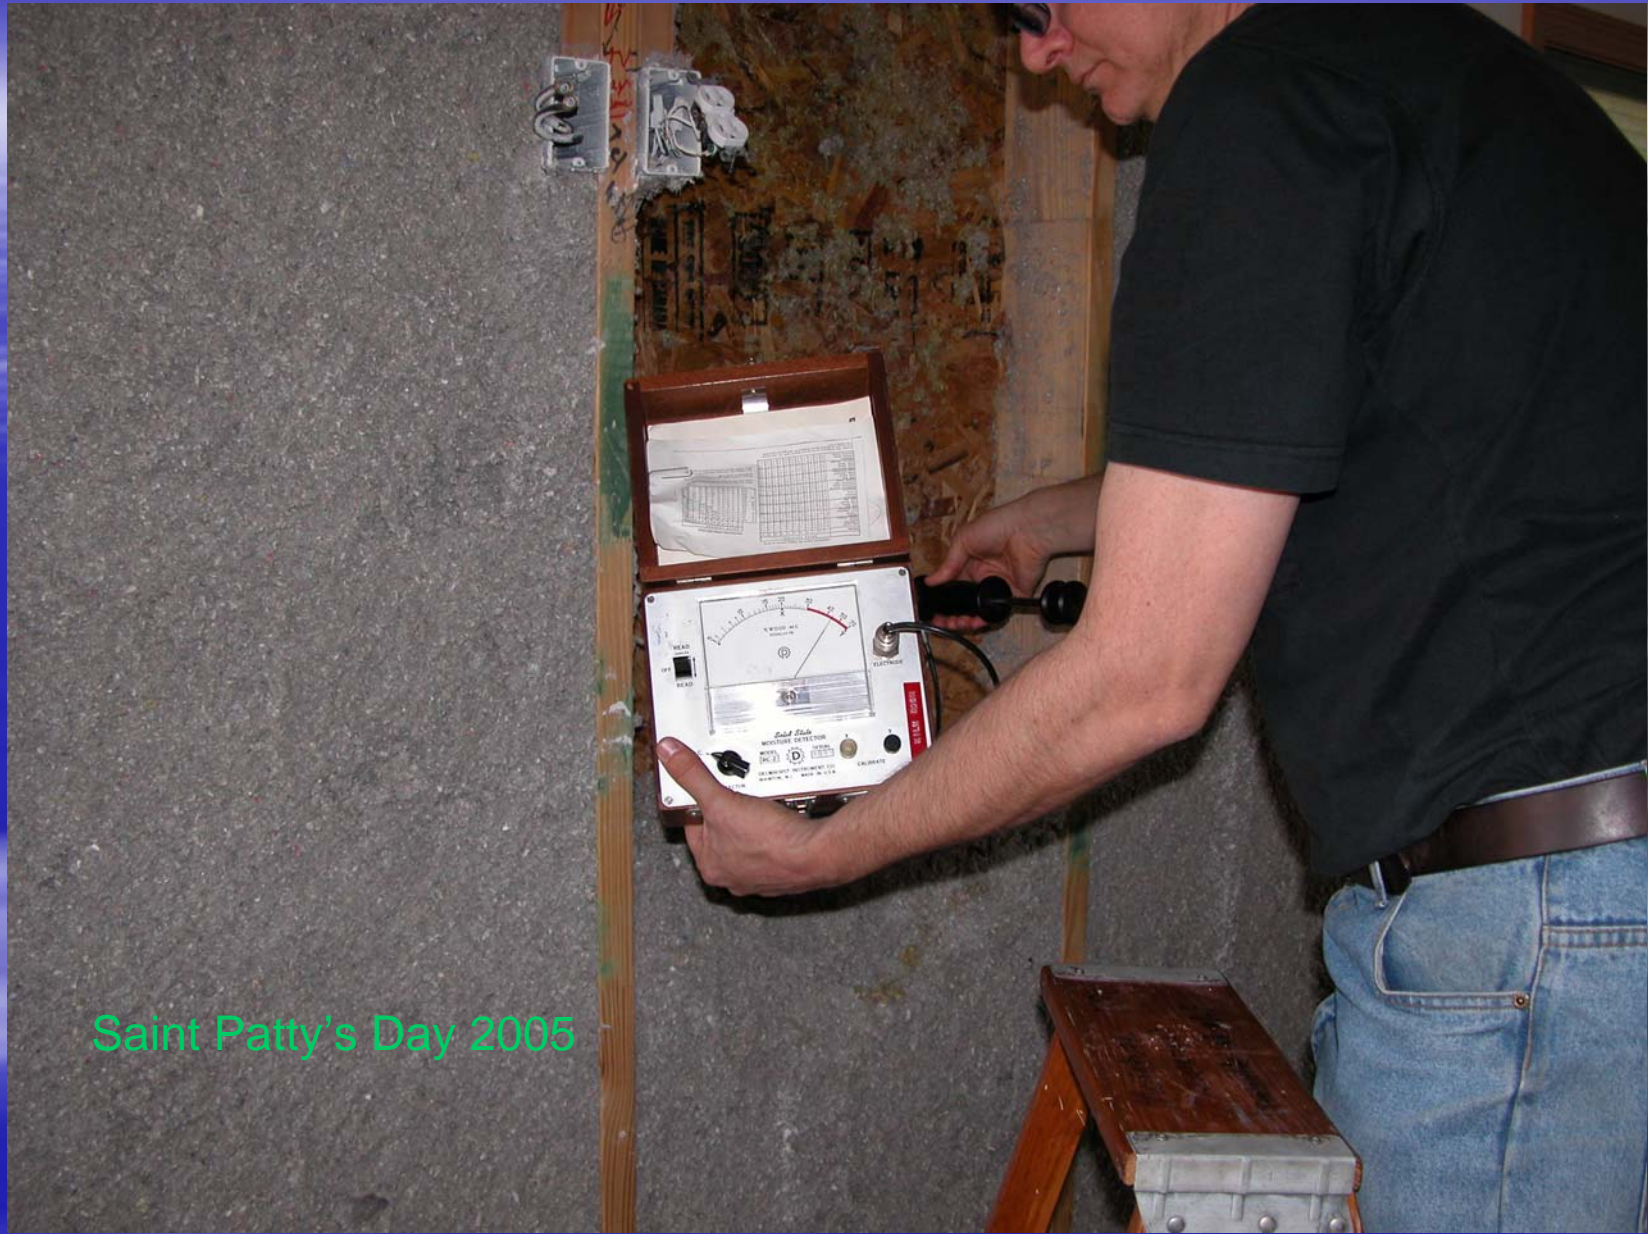
Saint Patty's Day 2005

- Disturbingly high sheathing mc levels by February occurred in all walls (except the one with interior polyeth) in all heating seasons (even the first two - - w.o. any humidification)

Opened a (non-instrumented) wall toward end of 4th heating season

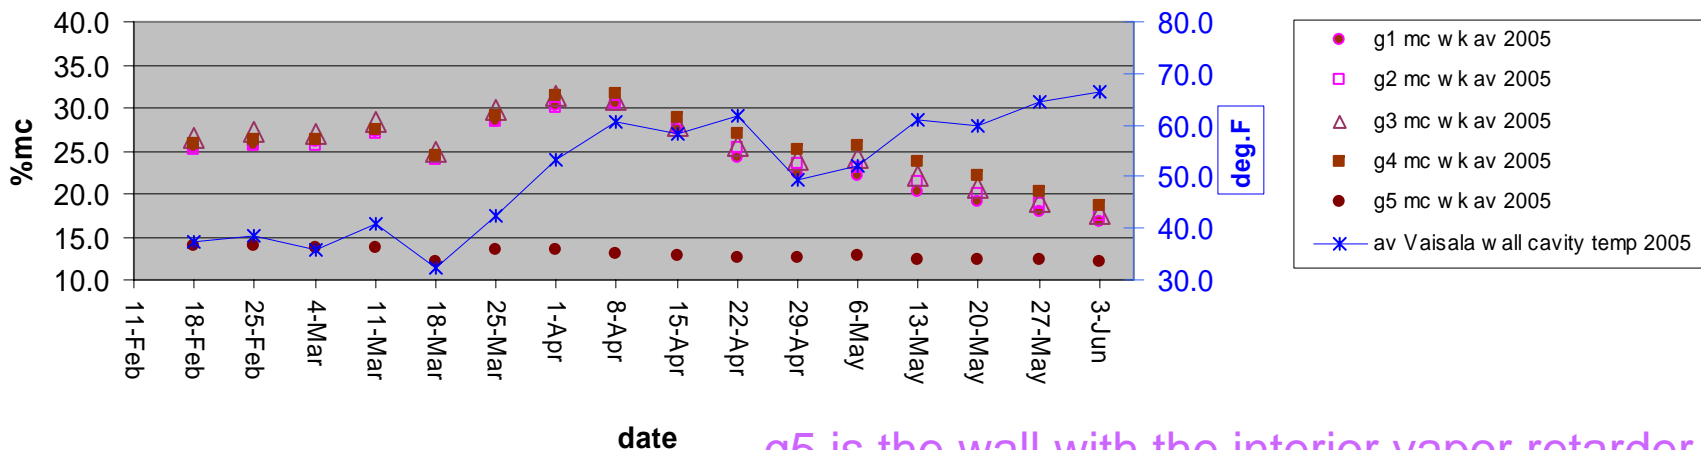
2005 mc wk av

Interior polyeth sheet kept the sheathing dry

g5 is the wall with the interior vapor retarder.

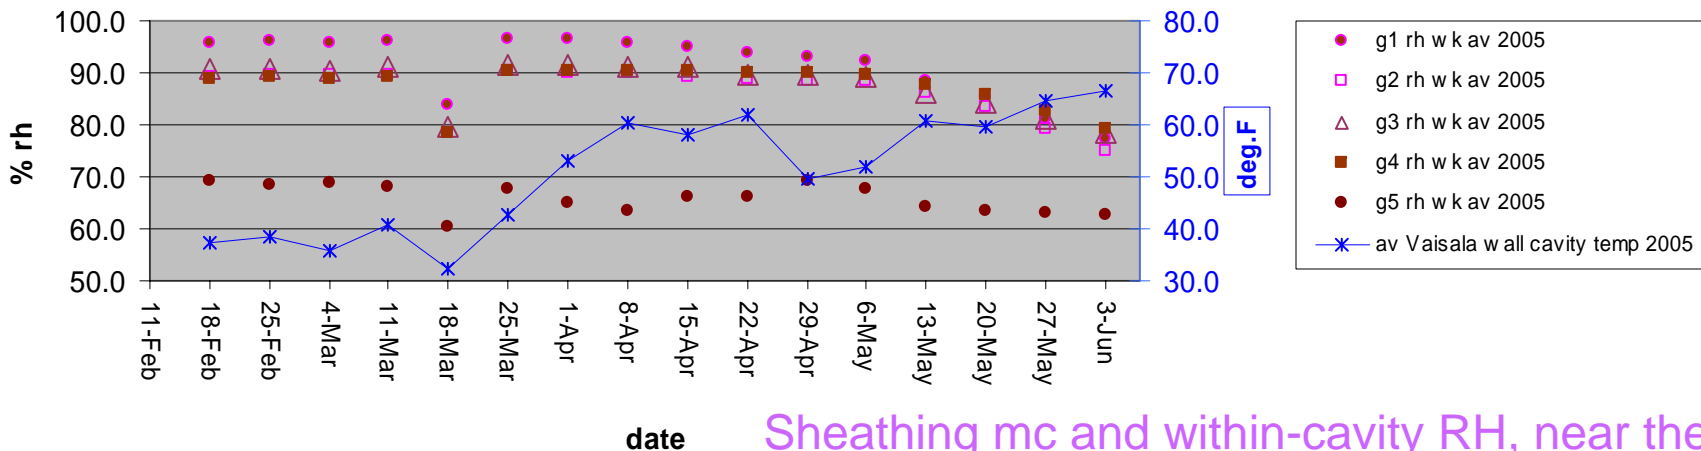
2005 rh wk av

Sheathing mc and within-cavity RH, near the sheathing, show similar trends

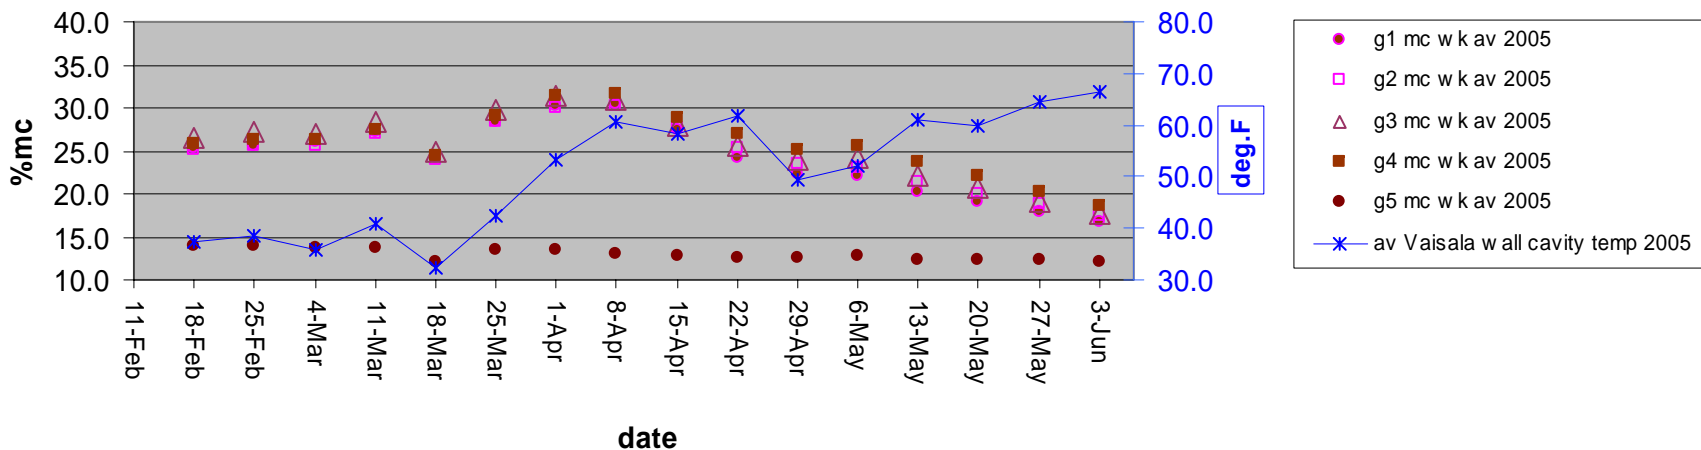
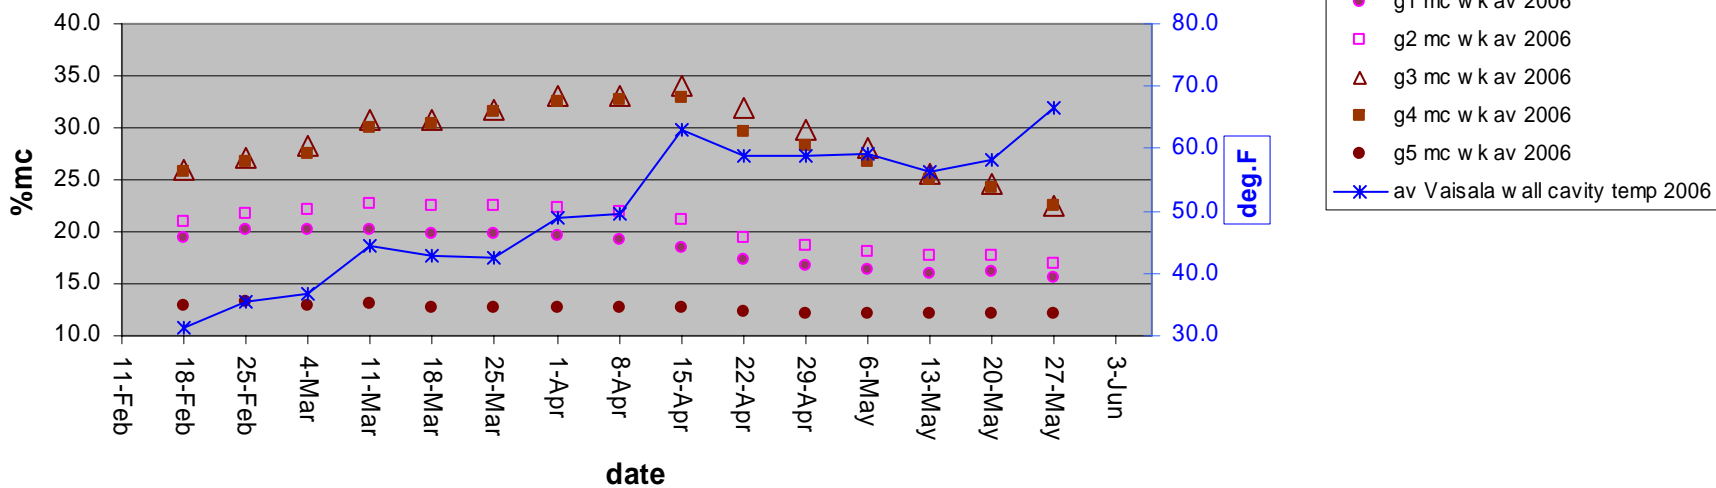
- Contemporary latex vapor retarding paint was not as effective as polyeth sheet, but it definitely helped.

Walls g2 and g3 got a coat of vapor retarder paint in early Oct. 2005

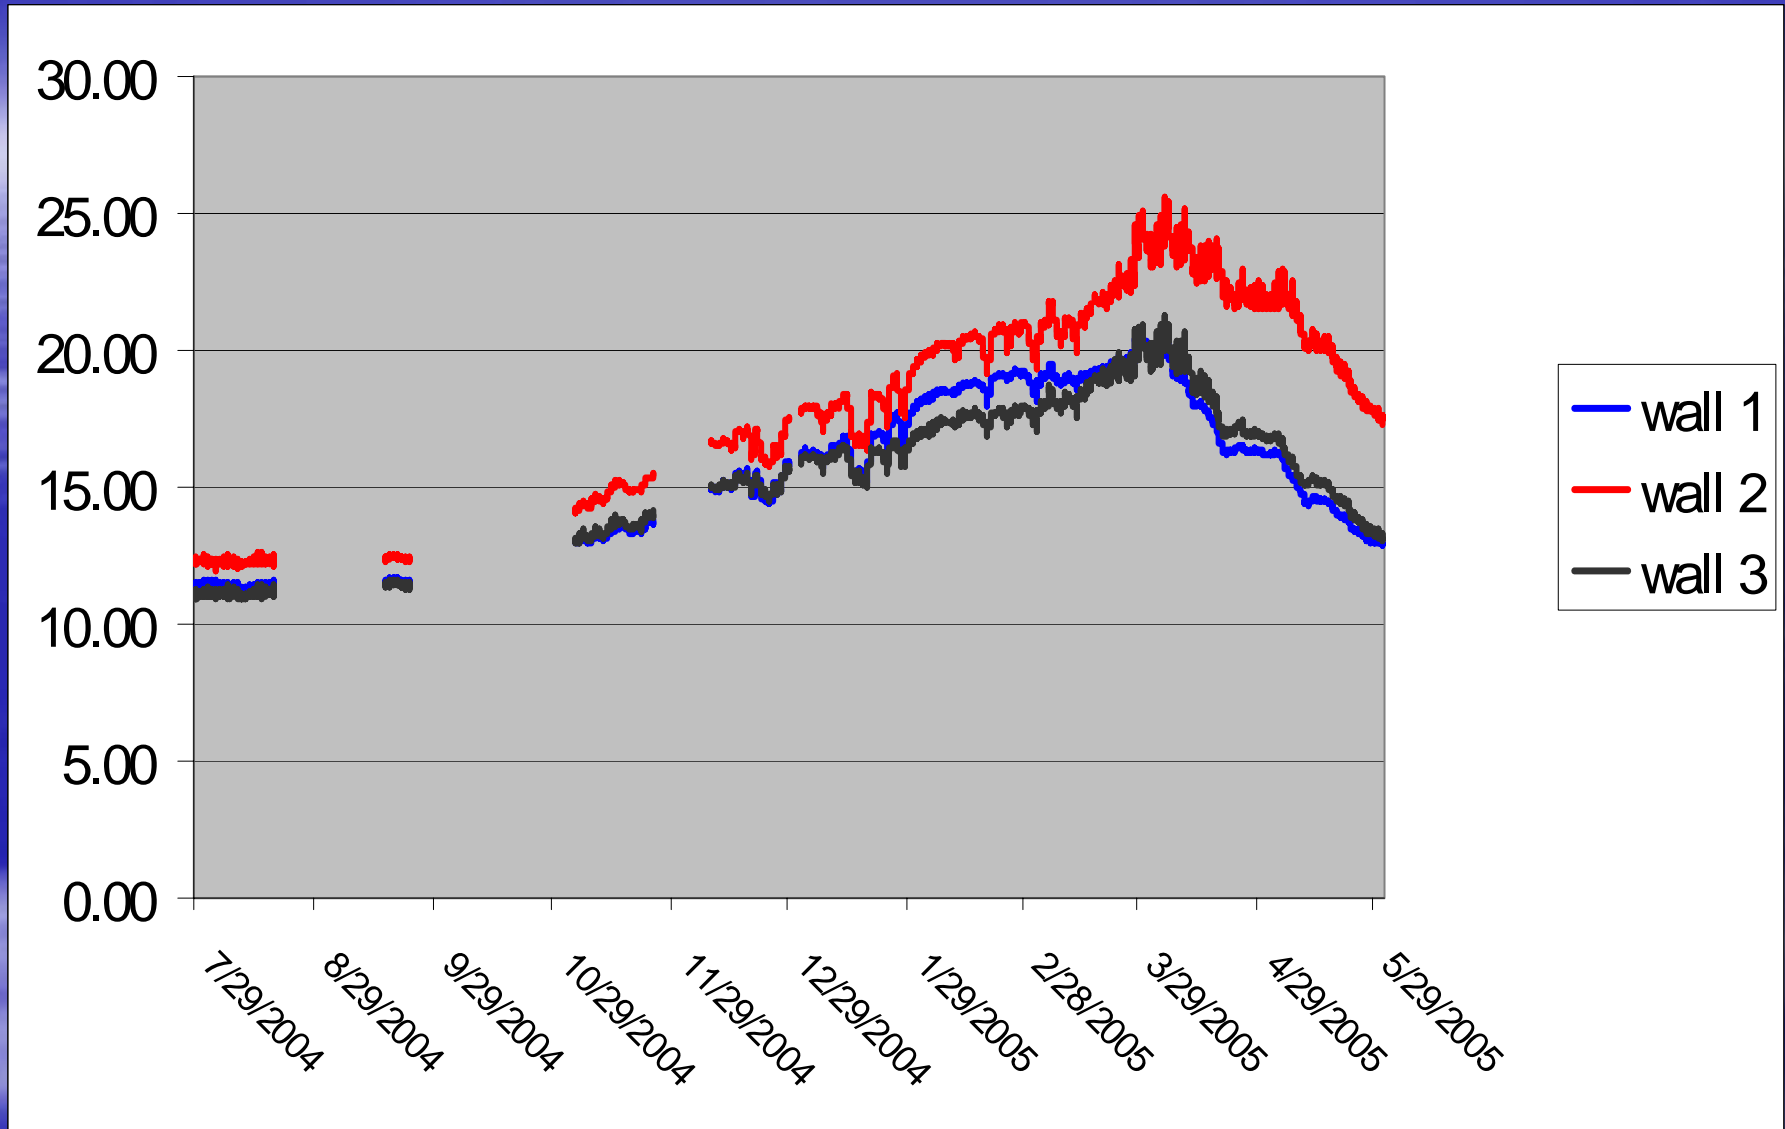
- Spacing the cladding out from the sheathing resulted in more rapid springtime moisture dissipation.
- Sheathing on north-facing walls behind spaced brick or spaced OSB lap siding had more favorable moisture history than sheathing on south-facing walls behind unspaced plywood panel siding or behind stucco.

Wall 2 had unspaced OSB siding.

Walls 1 and 3 had spaced brick and OSB claddings, respectively

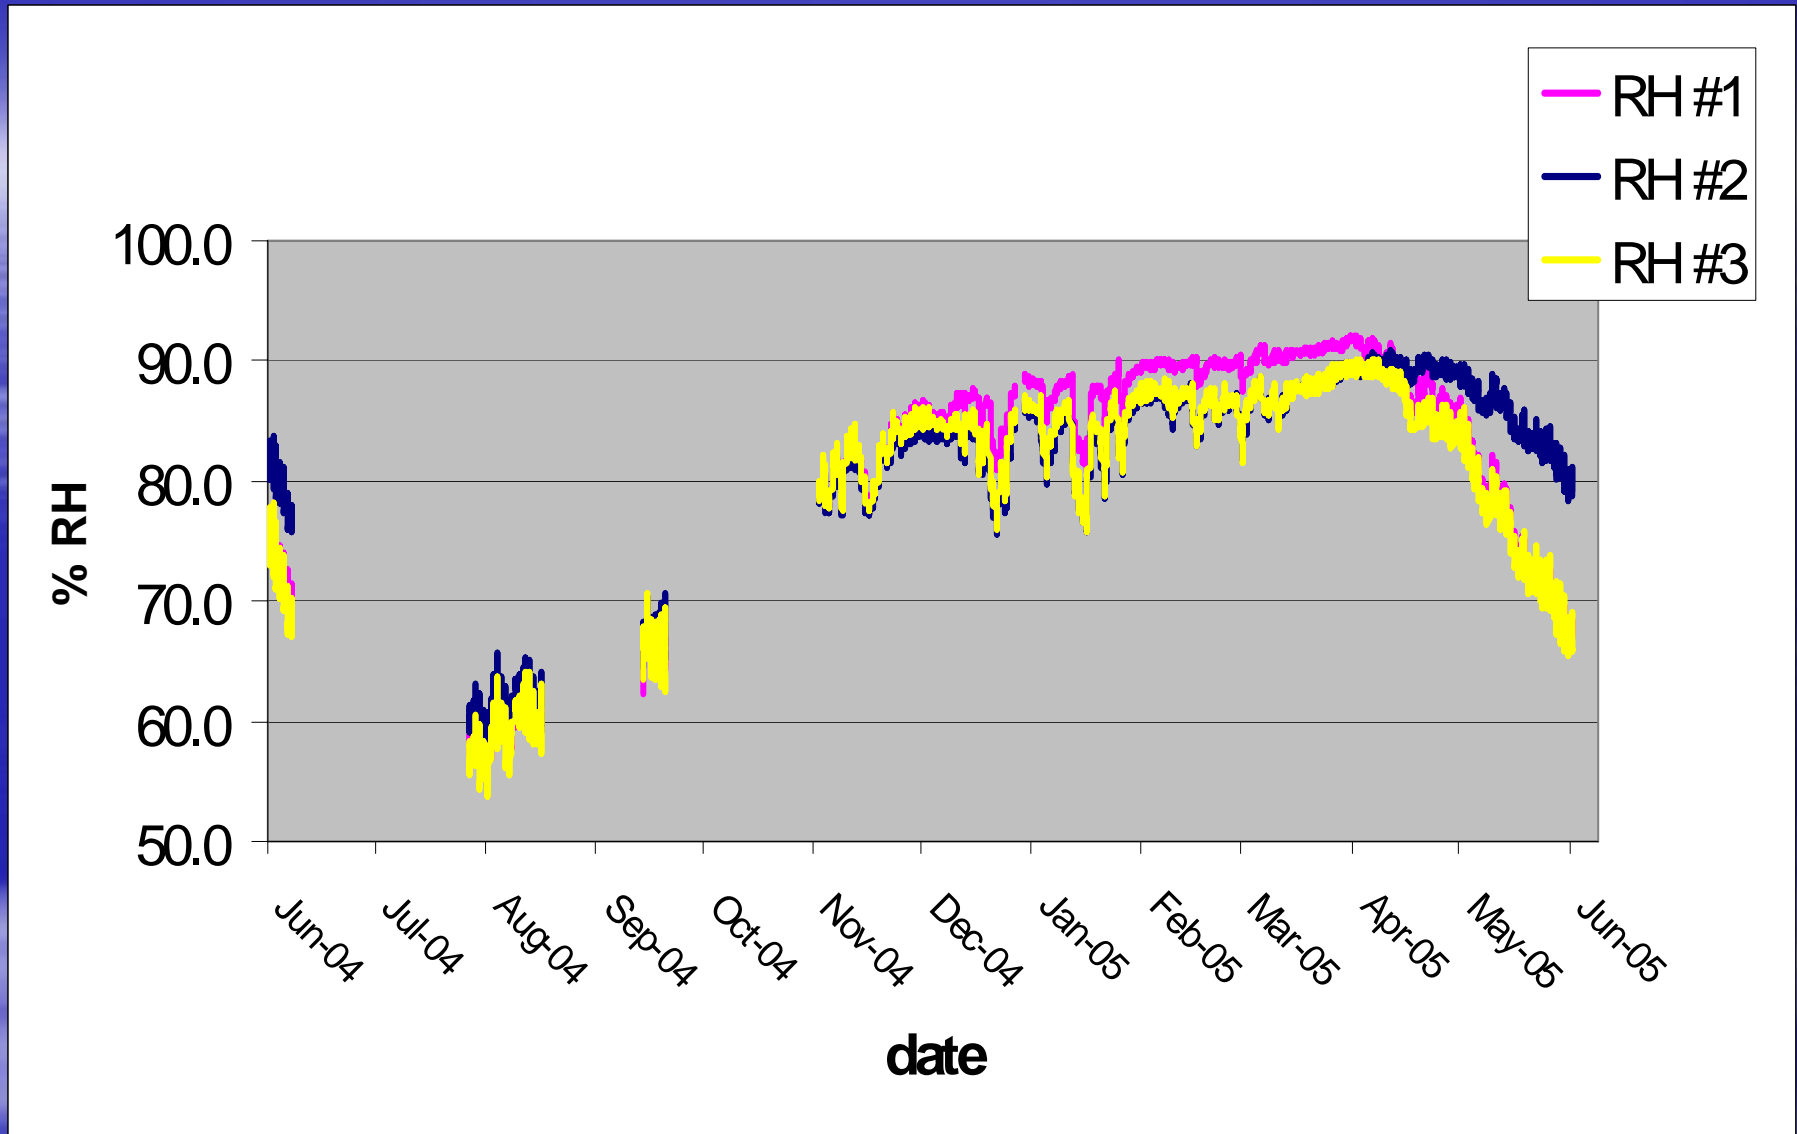
Springtime reduction in within-cavity RH was slower when cladding wasn't spaced
