Moisture and Housing Research at USDA - FPL

Charles Carll
Anton TenWolde

This presentation concerns

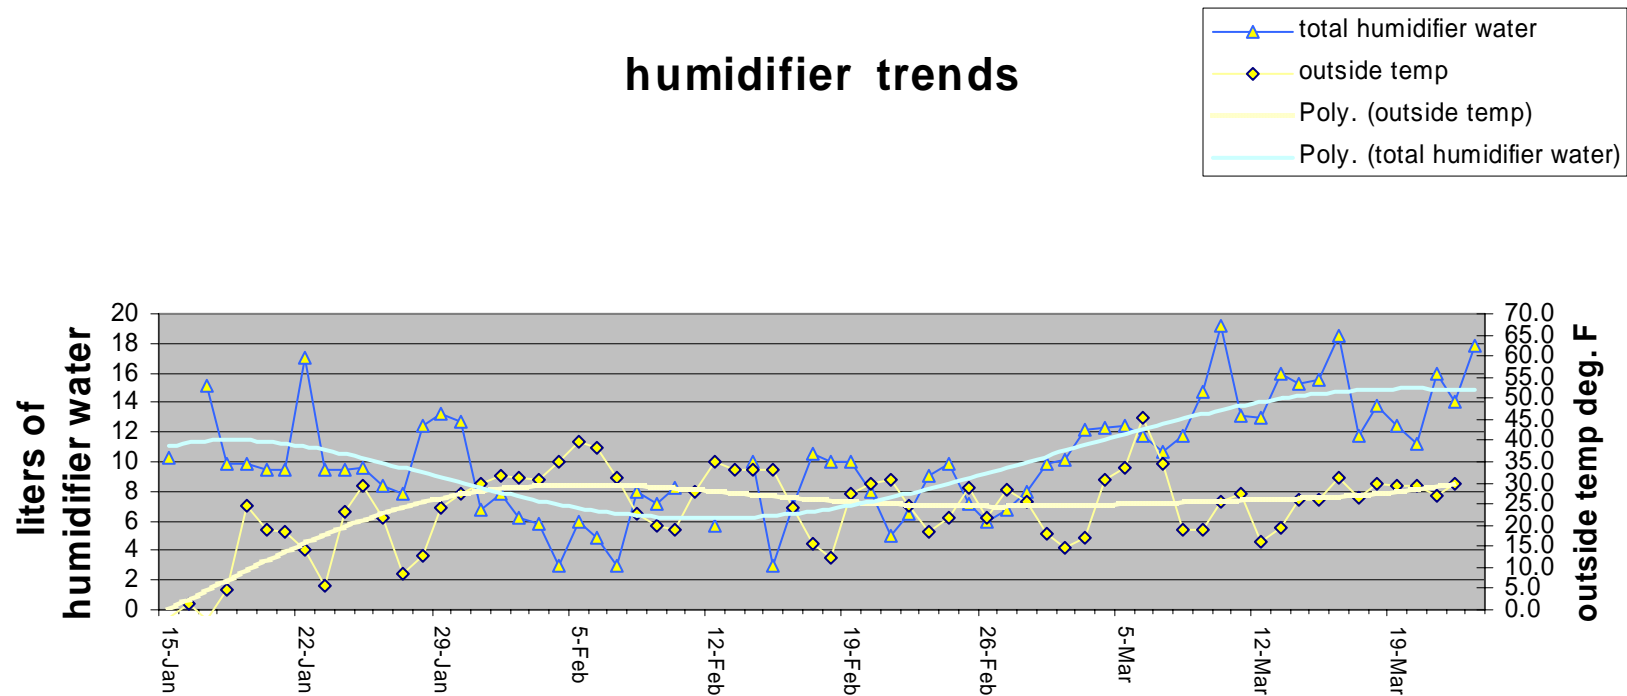
humidifier trends

Shows that humidifier input to maintain set-points was inversely related to outdoor temp (as expected), and that humidifier input was usually less than 14 L /day - - In short, it usually didn't take as much water to reach set-points as calculated (remember that 0.2 ACH vent rate was assumed by calcs)
